DEPARTMENT OF TRANSPORTATION

Quality Assurance and Source Inspection

Contract #: 04-0120F4Cty: SF/ALA Rte: 80 PM: 13.2/13.9File #: 1.28**WELDING INSPECTION REPORT****Resident Engineer:** Casey, William**Address:** 333 Burma Road**City:** Oakland, CA 94607**Report No:** WIR-026463**Date Inspected:** 04-Oct-2011**Project Name:** SAS Superstructure**OSM Arrival Time:** 700**Prime Contractor:** American Bridge/Fluor Enterprises, a JV**OSM Departure Time:** 1730**Contractor:** American Bridge/Fluor Enterprises, a JV**Location:** Job Site

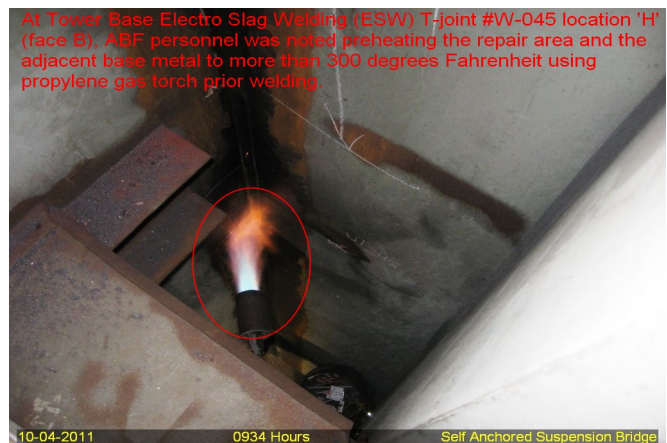
At Tower Base Elevation Electro Slag Welding (ESW) T-joint #W-045 location 'H' (face B), QA randomly ABF welder Richard Garcia continuing to perform 3G Shielded Metal Arc Welding (SMAW) cover welding repair due to excessive grinding on the visually noted overlap. The welder was observed welding in the 3G (vertical) position utilizing Shielded Metal Arc Welding (SMAW) with 1/8" diameter E7018H4R electrode implementing welding procedure ABF-WPS-D15-1000-Repair Rev. 2. The excavation was previously tested using Magnetic Particle Testing (MT) by ABF QC Salvador Merino and randomly verified by this QA with positive result. The repair excavation and the adjacent base metal were preheated to more than 300°F using the propylene gas torch. During the shift, ABF QC Salvador Merino was noted monitoring the welder. Measured welding parameter during welding was 140 amperes on a 1/8" diameter E7018H4R electrode. During the shift, weld cover repair at ESW location 'H' elevation 9 to 13 meters was completed and the welder has moved to elevation 0 to 9 meters of the same ESW location.

At Tower Base Electro Slag Welding (ESW) T-joint #W-045 location 'H' (face B), ABF welder Richard Garcia was observed performing 3G Shielded Metal Arc Welding (SMAW) welding cover repair on welded ESW.
